Sinkhole at Harris Riverfront Park

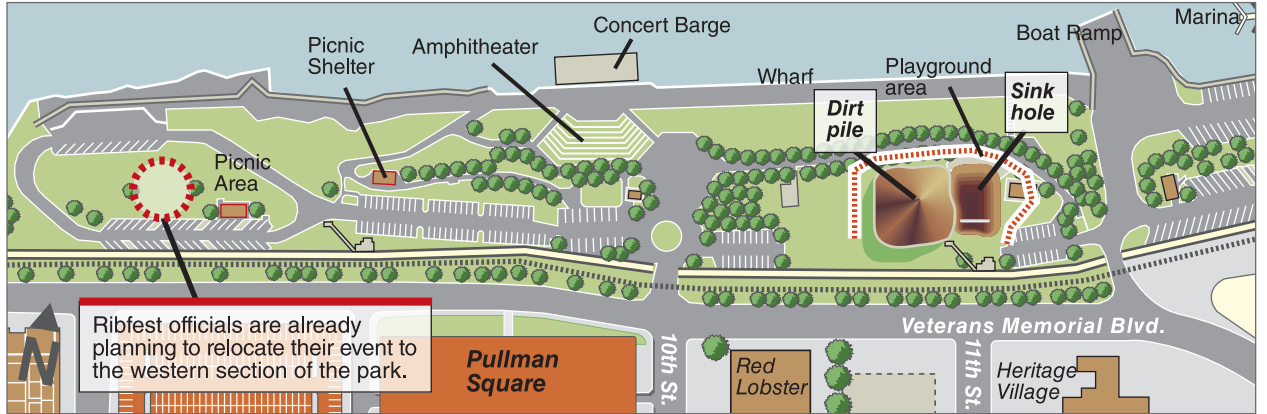
City workers replaced 20-feet of a 42-inch brick sewer line with a section of reinforced pipe. However, they noticed additional settlement at the sinkhole. After digging, they discovered a failed 12-inch cast-iron sewer main about 30-40 feet down that was pulling sand and other particles into the sewer line. They are now in the process of identifying how much pipe needs to be replaced before the hole can be filled.
